[Docket No. 2000-SW-12-AD; Amendment 39-13354; AD 2003-22-06]

Airworthiness Directives; Eurocopter France Model AS350B, B1, B2, B3, BA, C, D, D1, and AS355E, F, F1, F2, and N Helicopters

ACTION: Final rule.

2003-22-06 Eurocopter France: Amendment 39-13354. Docket No. 2000-SW-12-AD. Supersedes AD 98-24-35, Amendment 39-10921, Docket No. 98-SW-41-AD.

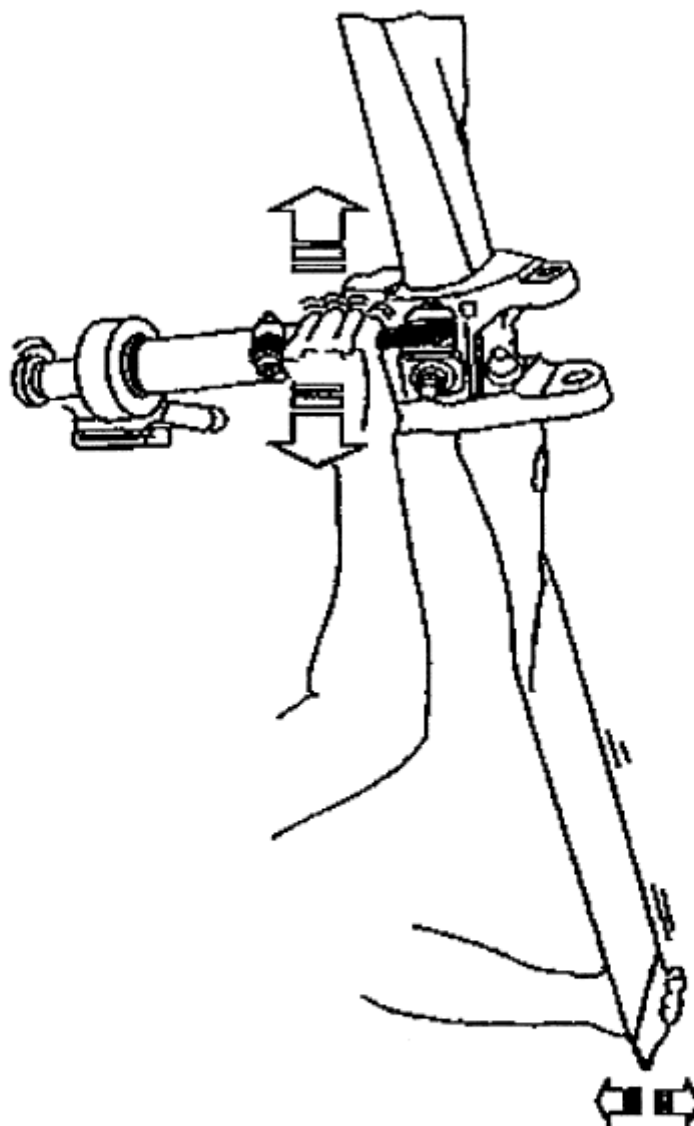
(a) Before the first flight of each day, place the tail rotor pedals in the neutral position. If the helicopter is fitted with a tail rotor load compensator, discharge the accumulator as described in the rotorcraft flight manual. Check the bearing for play on the helicopter, by observation and feel, by slightly moving the tail rotor blade in the flapping axis while monitoring the bearing for movement. See the following Figure 1 of this AD:

Figure 1: Manual Check for Play of the Tail Rotor Pitch Control Rod

(1) If the Teflon cloth is coming out of its normal position within the bearing, totally or partially, or if there is discoloration or scoring on the bearing, the bearing is unairworthy.

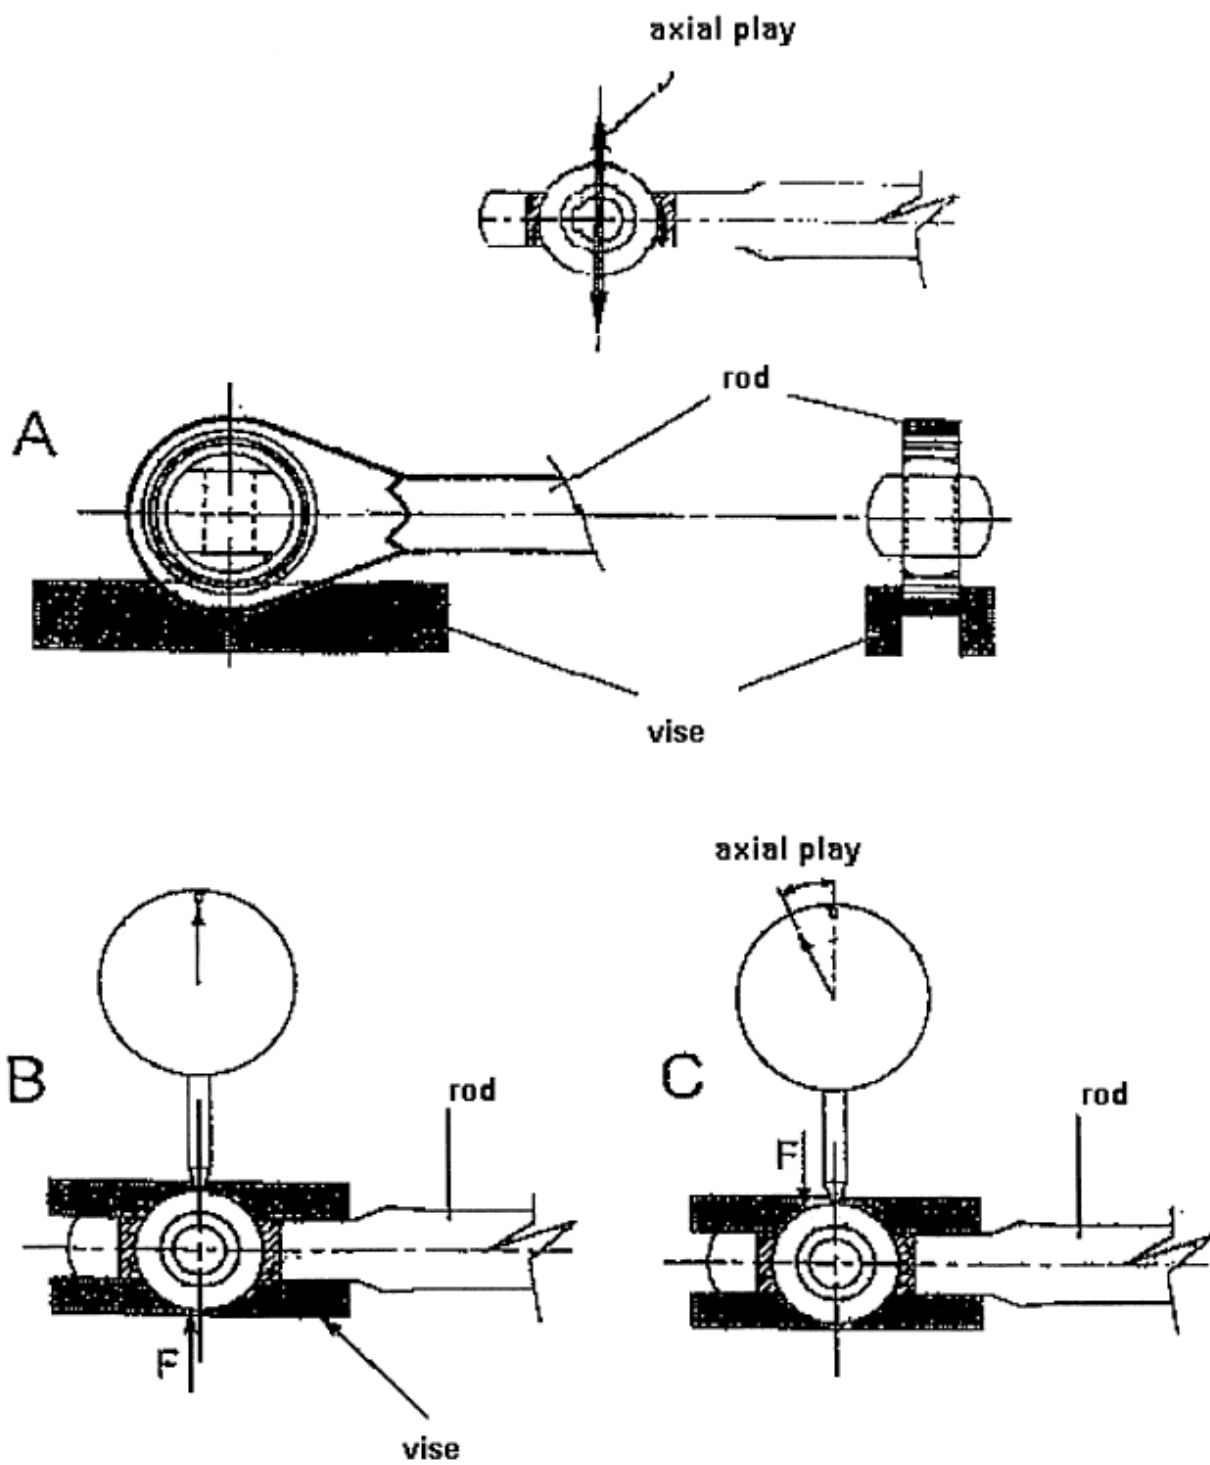
Figure 2: Measurement of the Axial Play (A) of the Bearing

(7) If the radial play exceeds 0.008 inch or axial play exceeds 0.016 inch, replace the control rod with an airworthy control rod before further flight.

- (1) Remove the control rod from the helicopter.
- (2) Mount the control rod in a vise as shown in Figure 2 of this AD.
- (3) Using a dial indicator, take axial play readings by moving the spherical bearing in the direction F (up and down) as shown in Figure 2 of this AD.
- (4) Mount the bearing in a vise as shown in Figure 3 of this AD.

(9) Thereafter, at intervals not to exceed 30 hours TIS, remove the control rod and again measure the bearing play with a dial indicator in accordance with this paragraph.

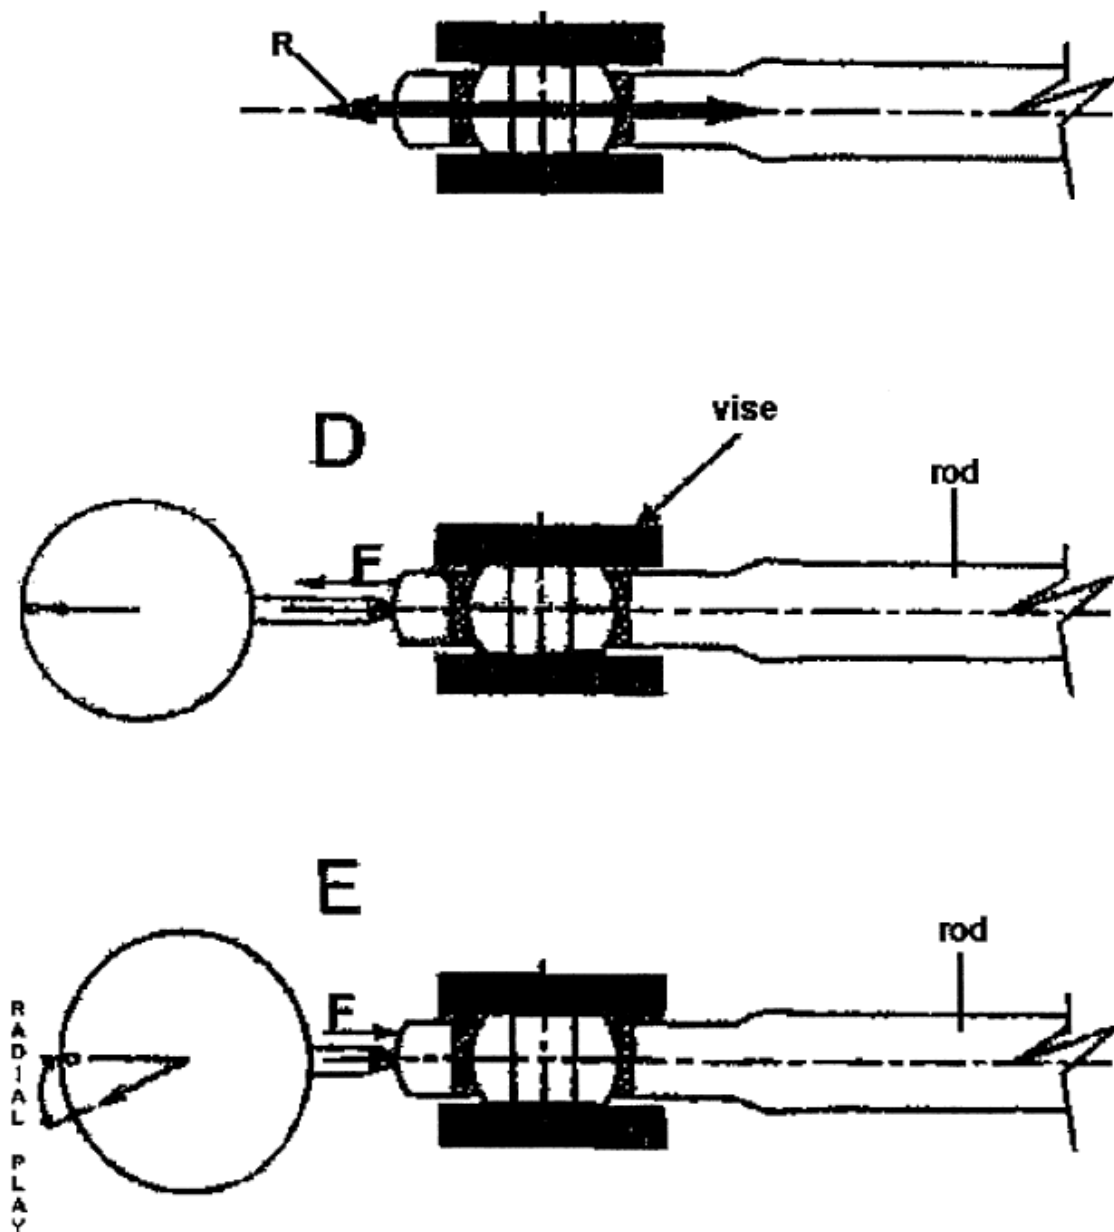
Figure 3: Measurement of the Radial Play (R) of the Bearing

(5) Using a dial indicator, take radial play measurements by moving the control rod in the direction F as shown in Figure 3 of this AD.
